2013 Paddock Case Study Grazing

Tracking gully activity in the Burdekin range lands

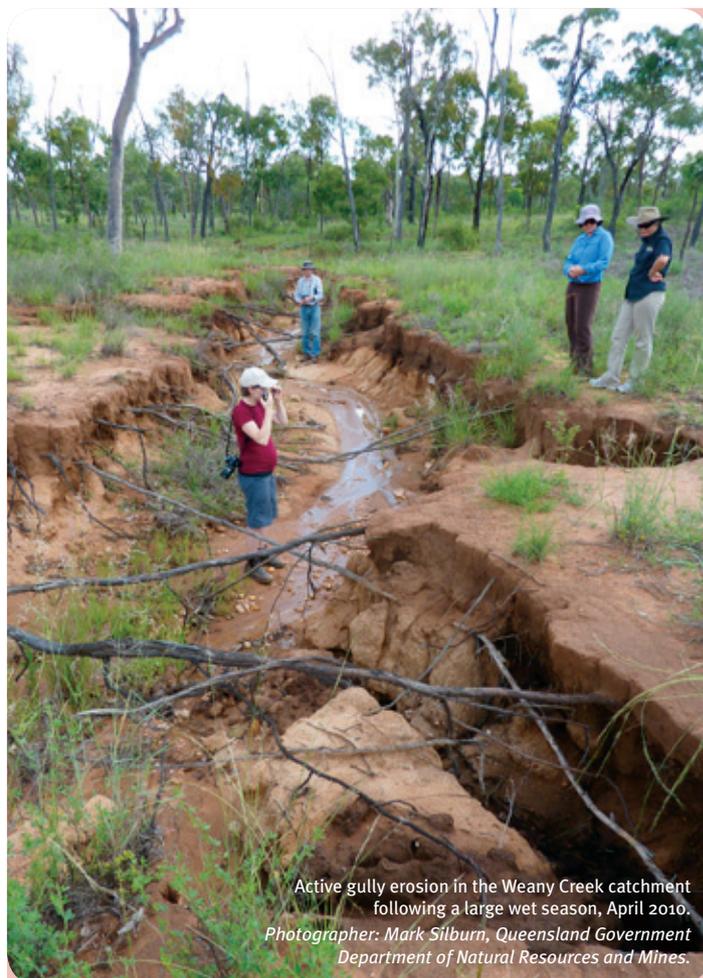
Active gully erosion in the Weany Creek catchment following a large wet season, April 2010.
Photographer: Mark Silburn, Queensland Government
Department of Natural Resources and Mines.

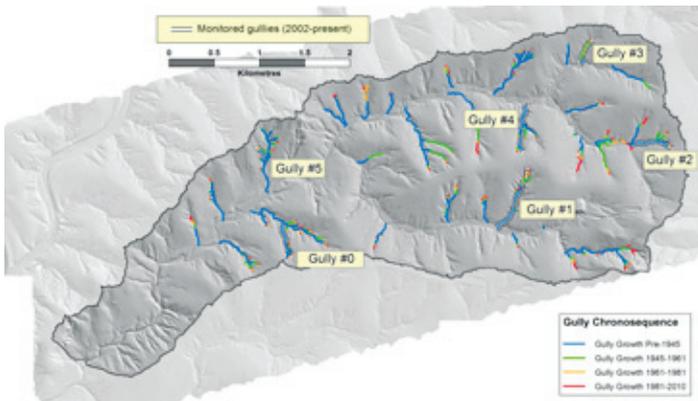
Growth of gullies in the Weany Creek catchment between each aerial photograph measurement period. Gullies with additional on-ground monitoring are indicated with labels. The land surface image was derived from airborne laser scanning commissioned by the Paddock to Reef program.

Detailed monitoring of six gullies showed that most erosion occurred at the gully headcuts rather than elsewhere in the gully. The headcut is the near-vertical change in elevation at the upslope end of the gully. The gullies tracked over time using air photographs were distributed across the catchment.

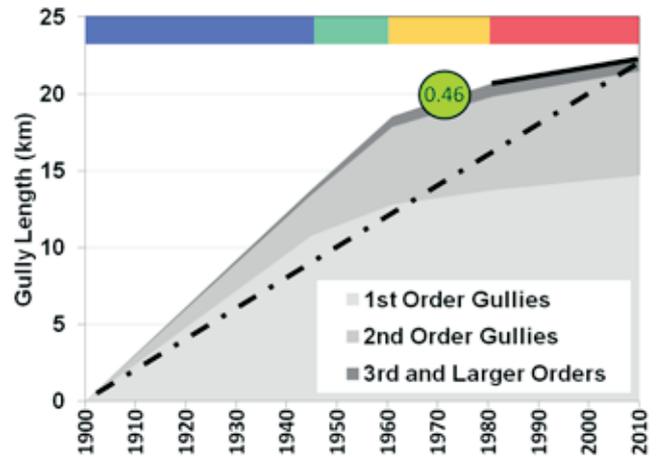
Increase in length of measured gullies in the Weany Creek catchment from 1945 to 2010. Number in green indicates the gully extension rate in the past 30 years as a proportion of the rate since gully commencement, assuming the year 1900 as the initiation of gullying in the catchment. First order gullies are those elements connected directly to the stream network, while second and third order gullies represent upstream 'forks'.

Since 1960, the rate of gully lengthening has slowed. Since 1980, the gullies have been growing longer through headcut erosion at approximately half (0.46 times) the average growth rate since gully erosion commenced.

This result assumes the average date of gully formation occurred at the junction with the main stream in 1900. Earlier gully formation is unlikely given the long-term decline in gully erosion rates generally observed after their initiation.

The decline in gully erosion rates is caused by reduced runoff volume as the gully head progresses upslope and the catchment area supplying runoff becomes smaller. However, while gully erosion may have slowed in the long term, recent big wet seasons have seen erosion in all monitored gullies and large increases in the volume of some gullies. Improving land condition can reduce runoff and consequently gully erosion rates.
